# Wing Camera

## OVERVIEW OF INNOVATION

### Missouri Department of Transportation

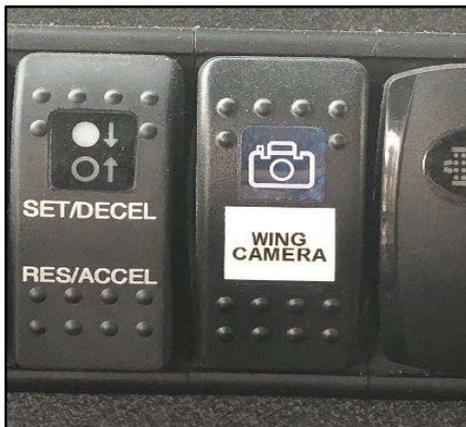
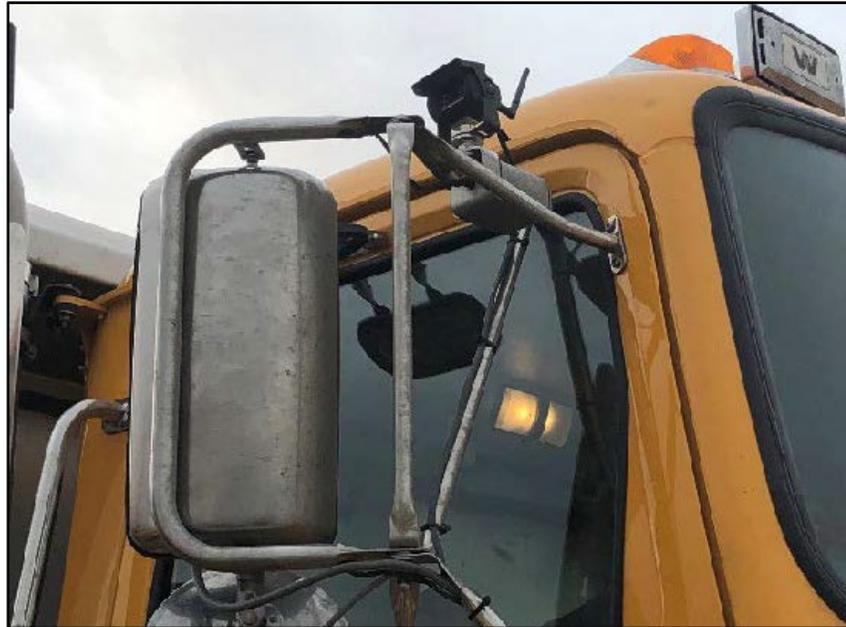
**With a backup camera mounted to the top of the passenger side mirror, you can see over the front mounted wing plow, making it easier to see cars or other obstructions while plowing.**

**When a wing plow is attached to a snowplow in the up position, it is impossible to see out the passenger window while plowing or when pulling out of an intersection. This requires lowering and raising the wing every time or continuously driving with it down, both of which could inadvertently damage a car, sign, mailbox, or anything along the roadway.**

**Drivers can now use the camera to see over the wing** in places they could not see before. This keeps the public and MoDOT drivers safer and reduces claims for damages.
